**Appendix 16.1**  
**Aquatic Field Survey Target**  
**Notes**

## River Boyne

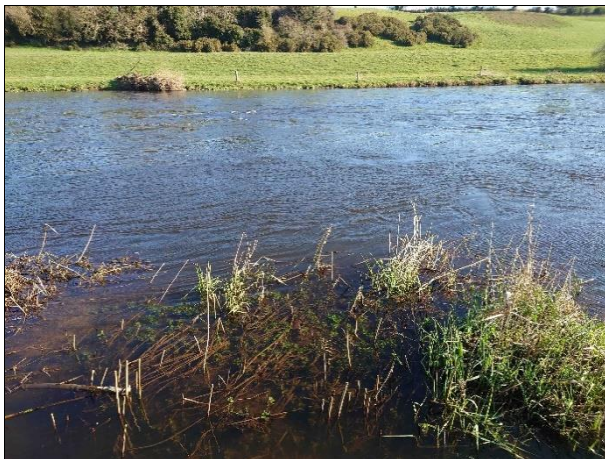
**B1** – Proposed crossing point, River Boyne

Survey Point	Habitat Notes - River Boyne (Figure A16.1a, Image A16.1a)
B1	Proposed crossing point ( <b>Image B1</b> ). Channel ~40 m wide with an area of low standing waves mid-channel. Substrates not visible owing to depth. Far bank, improved grassland; one low step followed by ~3 m high grassed embankment. RHS bank of damp meadow merging to river margin with 3-4 m wide sandy berm of <i>Glyceria maxima</i> (reed sweet grass), <i>Veronica</i> sp., <i>Phalaris</i> and yellow iris.
B2	Flood plain on the south bank of the crossing point is a damp meadow with low undulations running more or less parallel to the bank - possibly owing to the action of draining flood water. This area is the location of proposed central bridge pier foundations and is very waterlogged. One area ~6 m back from the bank ( <b>Image B2</b> ) forms a wet drain with <i>G. maxima</i> , creeping bent, <i>Phalaris</i> and <i>Ranunculus repens</i> . The LHS bank also has a fringe of <i>Iris</i> , <i>G. maxima</i> and <i>Phalaris</i> but is much narrower than the near (RHS) bank. The flood plain has a mix of grass, <i>Phalaris</i> , <i>R. repens</i> and <i>Iris</i> .

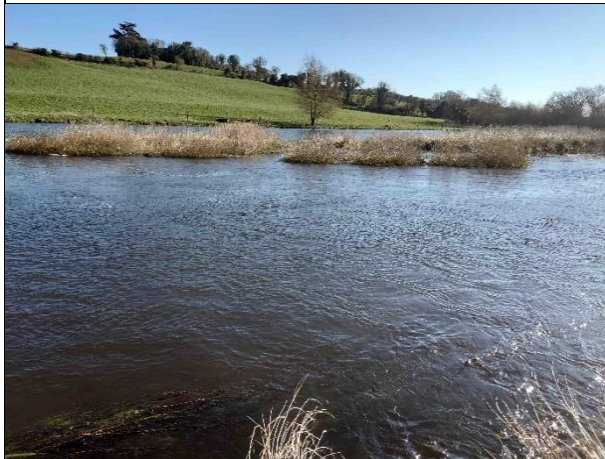
**B9** – Mid-channel island, just d/s crossing

B9	Upstream end of mid-channel island, dominated by <i>Phalaris</i> ( <b>Image B9</b> ).
B10	Beginning of standing waves in 'south' channel, very fast and turbulent.
B11	Fast glide ~1m+ deep on south channel inside mid-channel island ( <b>Image B11</b> ). RHS bank slightly undercut parallel to island. Less marginal vegetation and less nursery habitat for juvenile lamprey owing to scouring effect of faster flows.
B12	Downstream end of mid-channel island with <i>G. maxima</i> along water's edge. Fast glide. Good salmonid habitat. Willow on LHS banks.
B13	Downstream end of open bank walk (RHS), where the towpath comes close to the river. Diagonal weir has gaps; not presenting any barrier to fish or lamprey migration. Good salmonid holding water in glide/pool u/s weir. The back drain of the towpath in this area with <i>Veronica beccabunga</i> , <i>Phalaris</i> , Willow, <i>Myosotis scorpioides</i> and with <i>R. ficaria</i> , <i>Rumex</i> sp., and meadowsweet on drier ground closer to the towpath.

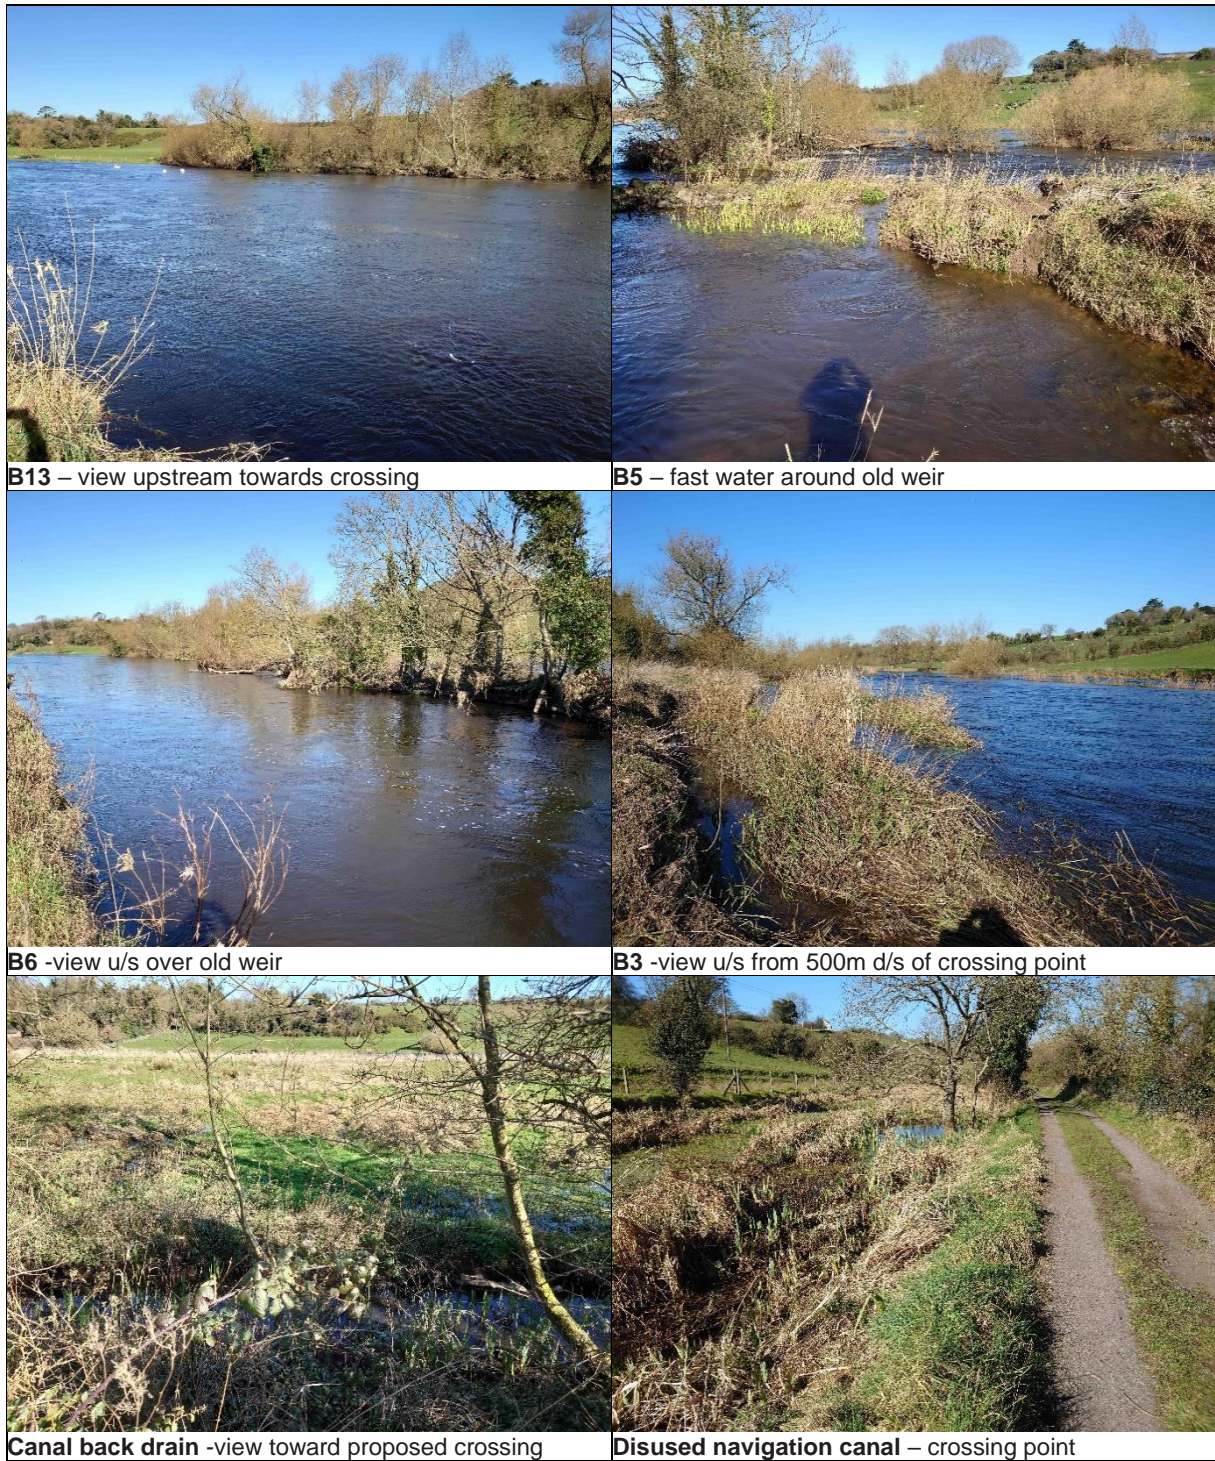
**Image A16.1a: River Boyne Survey Sites (19 March 2022)**

**B13 – view upstream towards crossing**

**B5 – fast water around old weir**

**B6 -view u/s over old weir**

**B3 -view u/s from 500m d/s of crossing point**

**Canal back drain -view toward proposed crossing**

**Disused navigation canal – crossing point**

B3	Downstream end of survey reach ( <b>Image B3</b> ), opposite a linear island running parallel to the RHS bank. The south floodplain has <i>Veronica</i> sp., <i>G. maxima</i> and <i>Phalaris</i> at the river's edge. Fast, deep rippled water / standing waves present. Good salmonid water.
B4	Side channel with steep eroding banks, immediately below the weir close to the southern bank.
B5	Immediately d/s weir, RHS side ( <b>Image B5</b> ) Fast water between gaps in weir. Good salmonid water.
B6	Immediately u/s the weir, RHS bank, deep, almost laminar flow ( <b>Image B6</b> ). Good salmonid holding water in glide/pool u/s of weir.
B7	Narrow flood plain on RHS bank between main channel and towpath. Dominated by <i>Phalaris</i> , grass and <i>R. repens</i> . In-channel deep glide with occasional club-rush ( <i>Schoenoplectus lacustris</i> ).
B8	50m u/s crossing Some marginal <i>Phalaris</i> and <i>G. maxima</i> on sandy shoals close to bank, likely good lamprey nursery– similar on far bank. Fast glide in-channel.

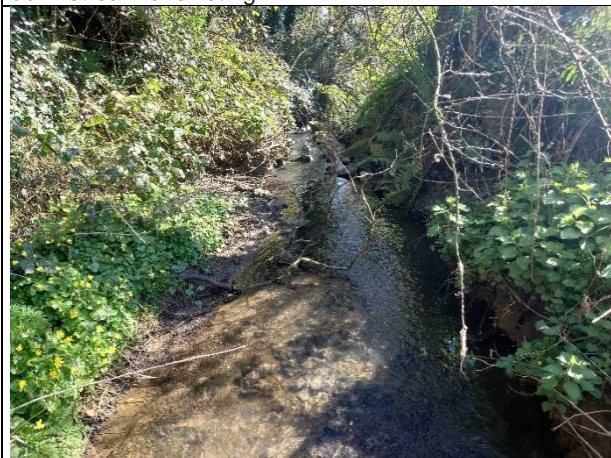
**M16** – macroinvertebrate kick sample site downstream of existing N2 crossing

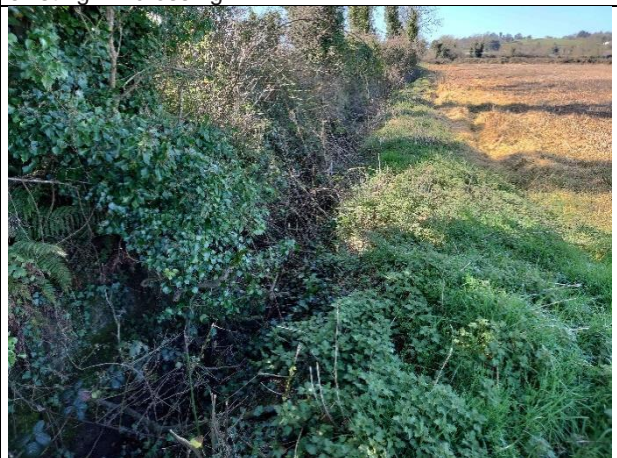
**M18** – view west along drain crossed by proposed bypass. No fisheries value, low ecological value.

<b>M17</b>	Moderate slope toward the stream from the south at this point, with tillage fields.
<b>M18</b>	Field drains adjoining Mooretown Stream ( <b>Image M18</b> ) - Southern hedge bank 2-3 m high with ash, ivy and bramble. Drain base with slick of standing water in places. No fisheries value, standing pools may support amphibians at times. A drain turns at right angles to the east-west drain here and ‘flows’ south toward the stream. <i>Ranunculus repens</i> and willowherb grow in the base.
<b>M19</b>	Same drain as at M18 but at the western end of the same field. Base of drain damp ( <b>Image M19</b> ). No fisheries value and low ecological significance overall.
<b>M20</b>	Dry field boundary drain running south from M19 to the Mooretown Stream ( <b>Image M20</b> ). No aquatic ecological value.

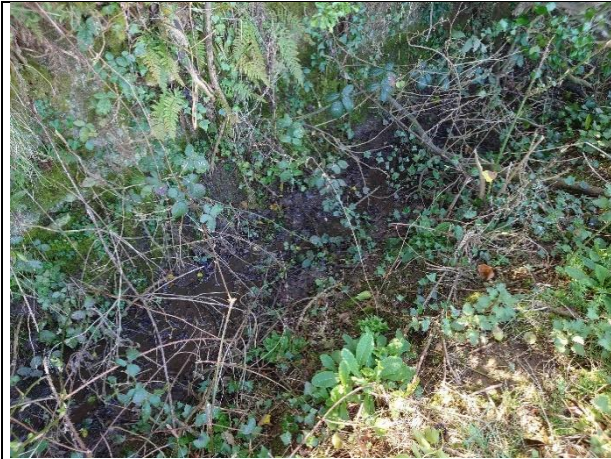
**M19** – base of drain that “flows” between N19-N18; damp, slick mud with no fisheries value.

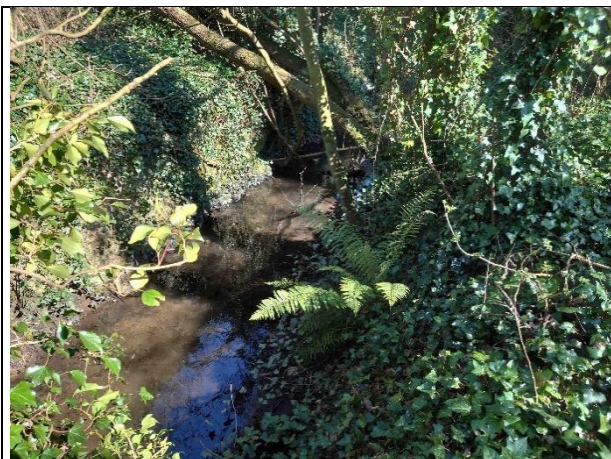
**T21 – Thurstianstown Stream, typical silty glide habitat**

Survey Point	Thurstianstown Stream (Figure A16.1c, Image A16.1c)
<b>T21</b>	~180 m upstream of road crossing, the stream forms a uniform glide with heavily silted substrate, ~2 m wide ( <b>Image T21</b> ). Heavily drained, deepened and widened. The habitat is unsuitable for trout, owing to predominantly slack flows and heavy siltation, with no suitable gravelly riffles. If trout were present, they would be in low numbers and foraging from other breeding sites (not this stream section). Good lamprey ammocoete habitat the species were able to spawn in the system, which is very unlikely owing to lack of suitable gravels and poor water quality.
<b>T22</b>	A heavily silted side drain ~1.5 m wide and 15 cm deep, joins the ‘main’ channel at this point ( <b>Image T22</b> ).
<b>T23</b>	‘Main’ channel of stream, forming a uniform silty glide. Both banks heavily shaded by sycamore, hawthorn and ivy. The stream lacks flow diversity and has no hard substrates. Very poor fisheries habitat, other than 3-spined stickleback perhaps, and eel. The land is flat to the east towards the receiving drain with the same silted glide persisting into its upper reaches.

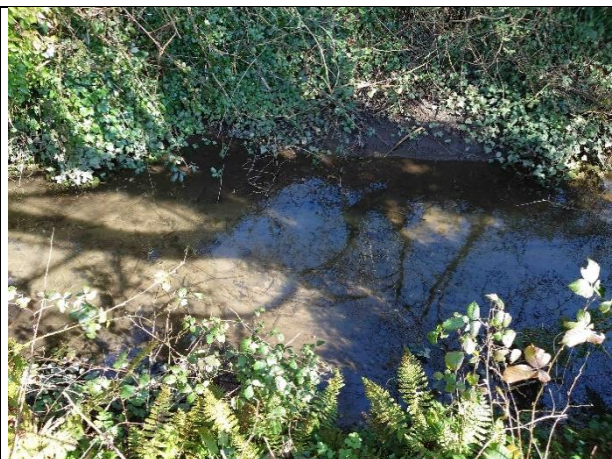
**T22 – heavily silted side drain adjoining Thurstianstown Stream**

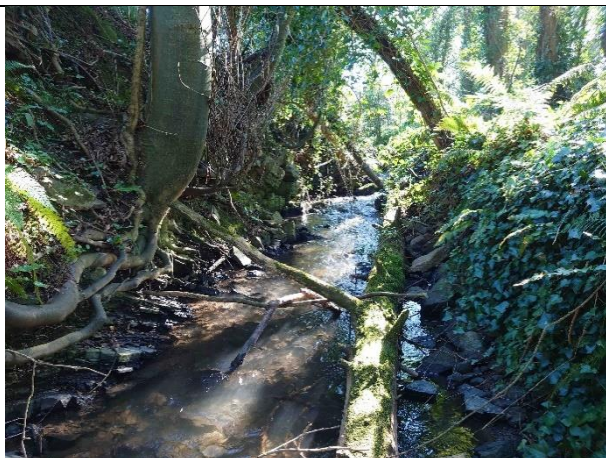
**T24 – Thurstianstown Stream, view upstream over macroinvertebrate kick sample site**

<b>T24</b>	~200m downstream of the local road, where the first riffle occurs ( <b>Image T24</b> ). The stream had coarse substrates for a very short stretch (10m). ~1.5 m wide, 15-25 cm deep. Cascade/riffle over a substrate of angular cobble 60% and pebble 40%. No instream vegetation. Heavily shaded from banks with ivy, fern and sycamore. Macroinvertebrate fauna indicative of Q3 – ‘poor’ status.
<b>T25</b>	Straightened and deepened field boundary drain near existing N2, at location where proposed attenuation pond would discharge ( <b>Image T25</b> ). Trickle base-flow in drain, RHS hedge with ash, hawthorn, ivy and bramble; LHS grassed with herb species.

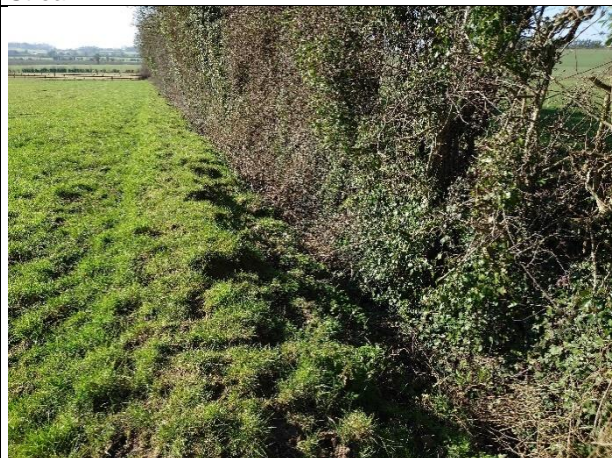
**T25 – view west from proposed attenuation pond discharge point near existing N2; trickle flow in drain**
